Re: Consent Decree, LCP Chemicals Superfund Site, Brunswick, GA
Civil Action No. 2:16-cv-00112
Pre-Design Investigation Evaluation Report and Supporting Documents

April 2019
LCP Chemicals Superfund Site Operable Unit 1

Pre-Design Investigation Evaluation Report

Prepared by
Anchor QEA, LLC
10320 Little Patuxent Parkway, Suite 1140
Columbia, Maryland 21044

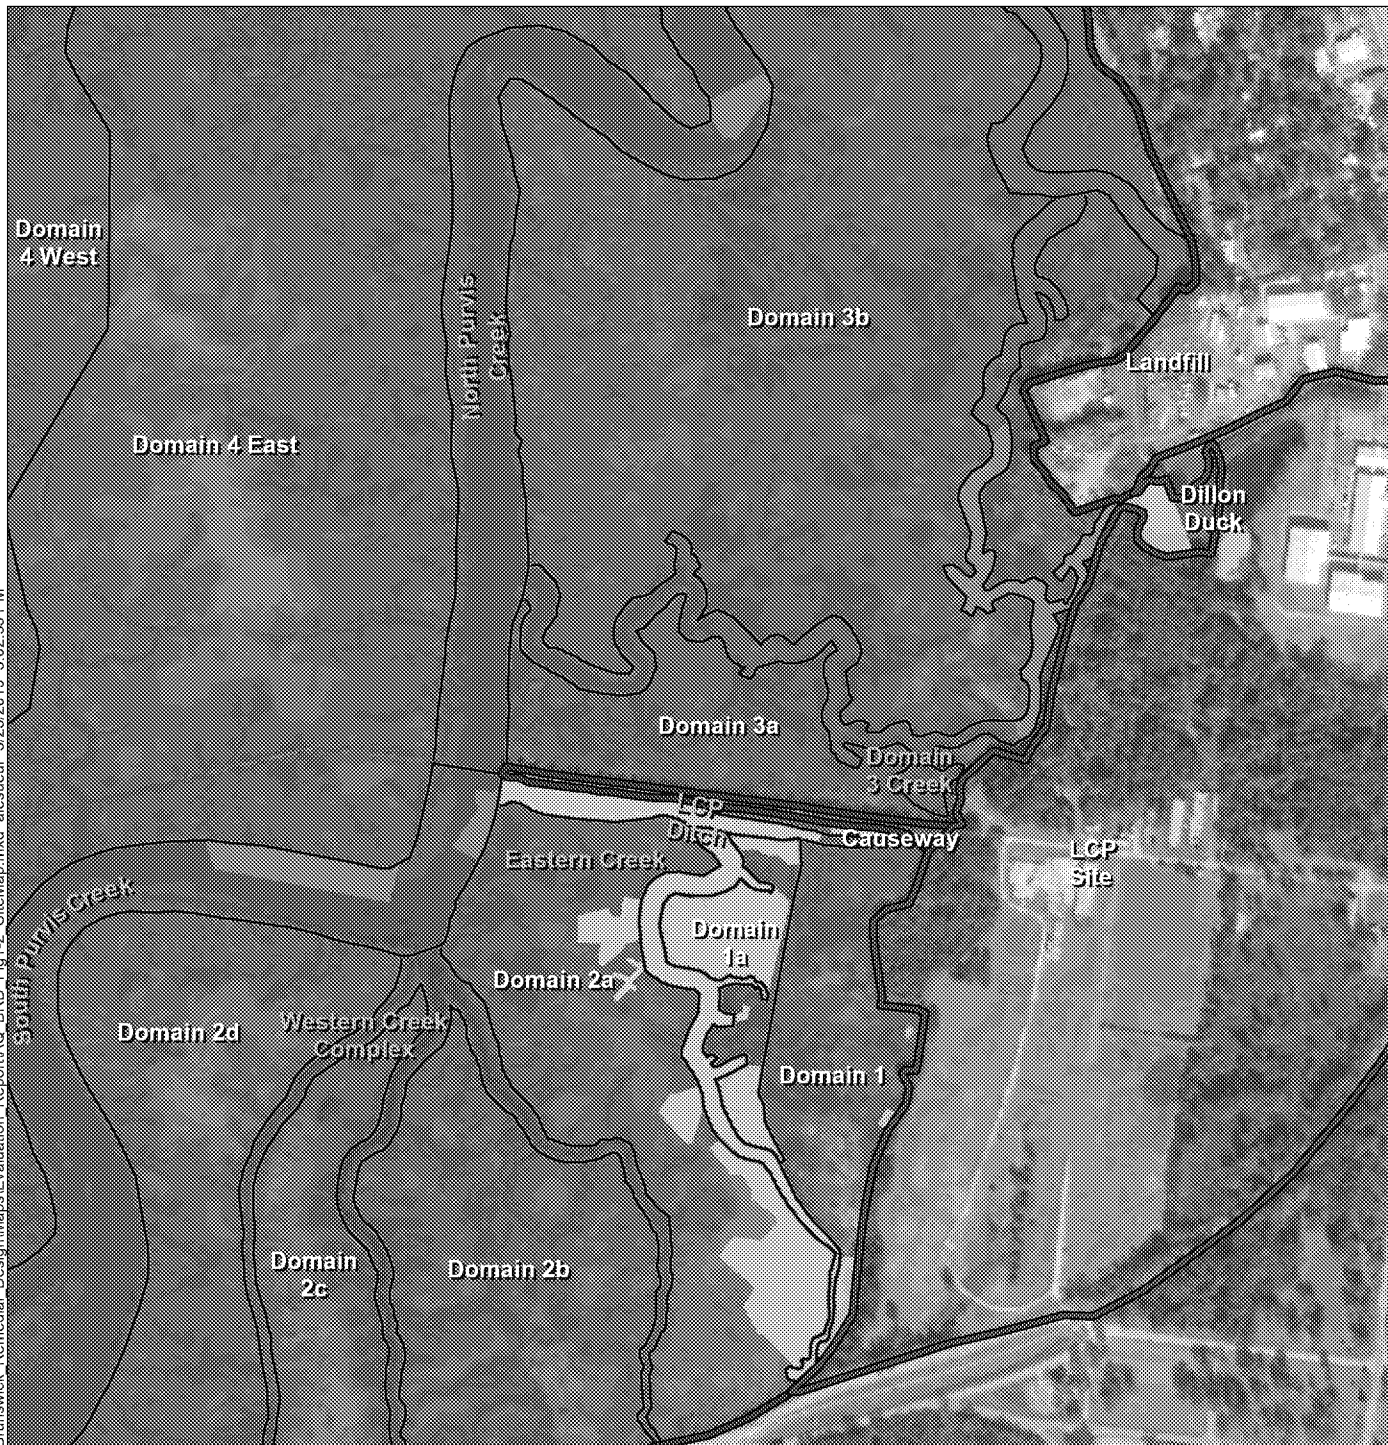
Remediation Areas

The areas to be remediated are depicted in Figure 1-2, and the components of the remedy are further described in the following subsections.
